# Home Inspection Report

123 Main Street, Seattle, WA 98135

**Inspection Date:**

Thursday March 15, 2012

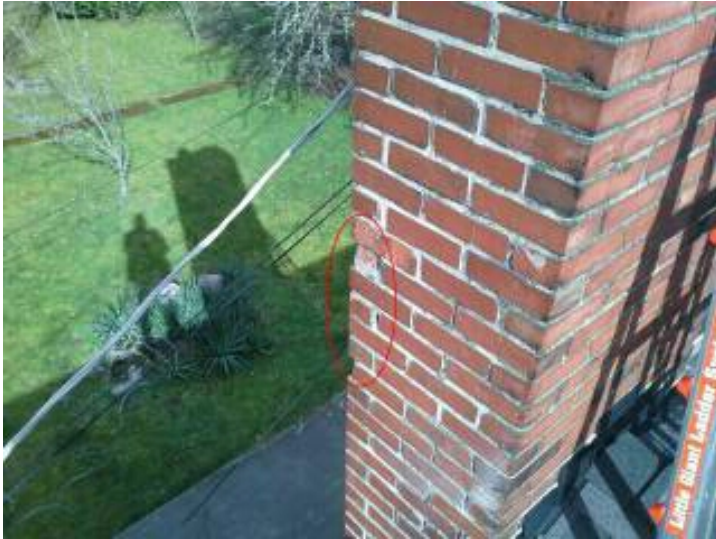
some brick spalling

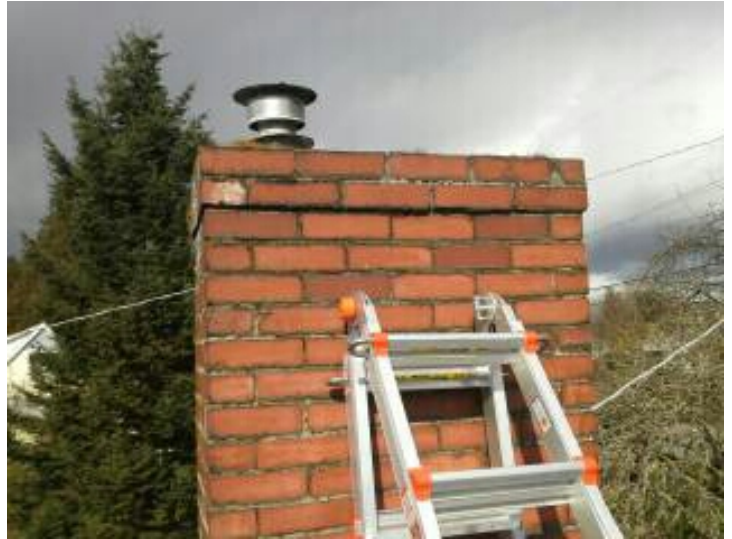
Comments Recommend capping the flue with a screened weather cap. Chimney chase is unlined - recommend chimney sweep or mason review.

recommend adding chimney cap

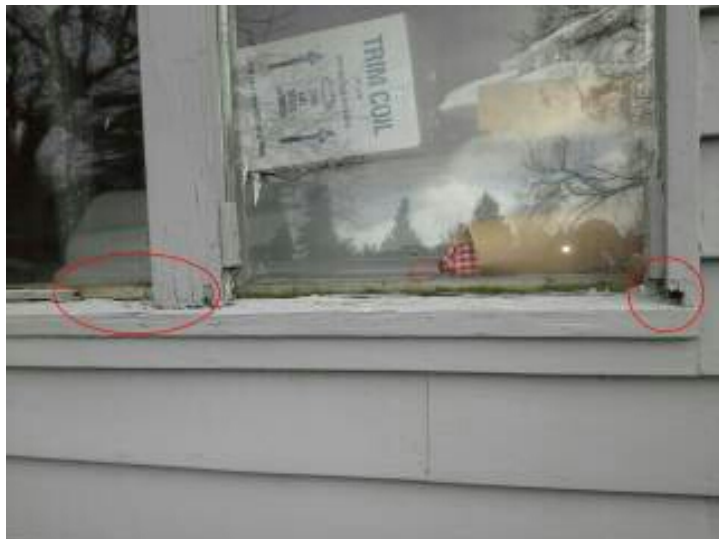
wood rot present at rear of garage

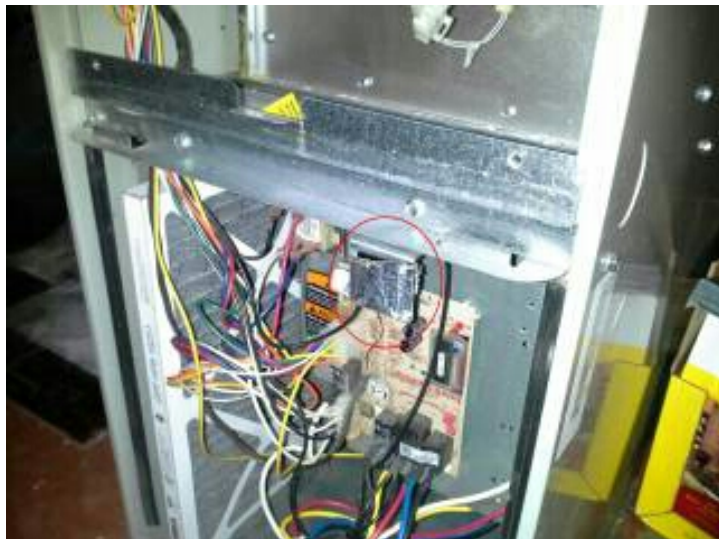
safety switch appears taped over. Recommend removing tape.
